### Lab trial compatibility of paint

in reference to your email dated 31 January 2012 we did investigation of compatibility of diluted and undiluted paint to SP520 / SP525. The issue was requested by Tremco illbruck r.s.o., by Stanislav Jirak.

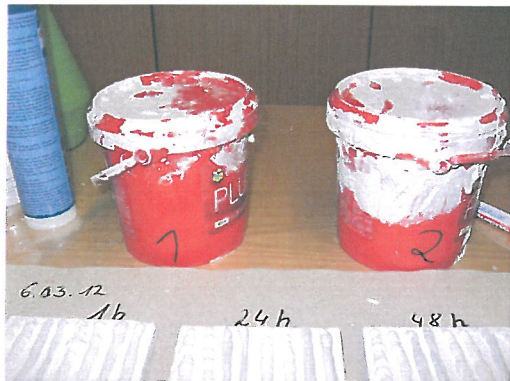
Picture 001

1. No incompatibility was evaluated. Stripe form the paint brush are visible.  
No leaching was evaluated at all these samples.  
picture 001
2. With coating on one hour cured sealant no incompatibility was evaluated.  
With coating after twenty-four hours cured sealant incompatibility (breaks, separation in coating surface) was evaluated.  
With coating on forty-eight hours cured sealant incompatibility (breaks, separation in coating surface) was evaluated.  
No staining/bleeding was evaluated at all these samples.  
picture 002

With these results incompatibilities are evaluated. We will suggest to coat the sealant SP520 and SP525 with paint Primalex Plus as recommended from Primalex between one and three hour after sealing. Leaching from sealant to the paint as described from Tremco illbruck r.s.o. could not be confirmed by this investigation. No leaching/stains were found even after 10 weeks after paint application.

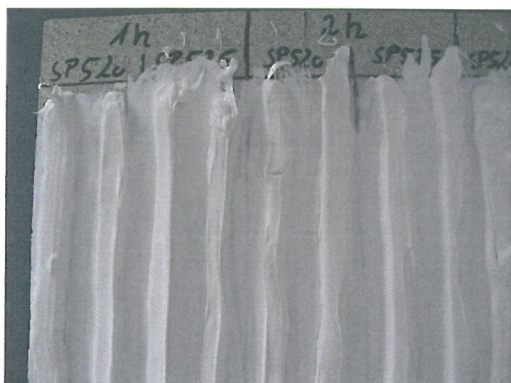
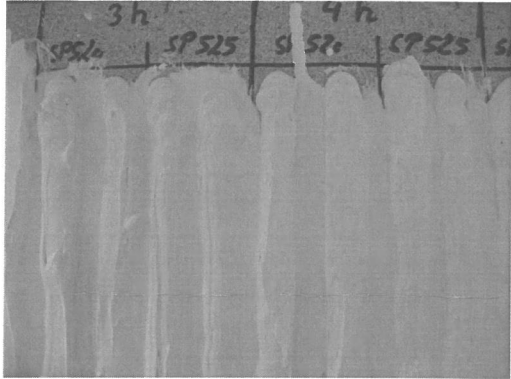
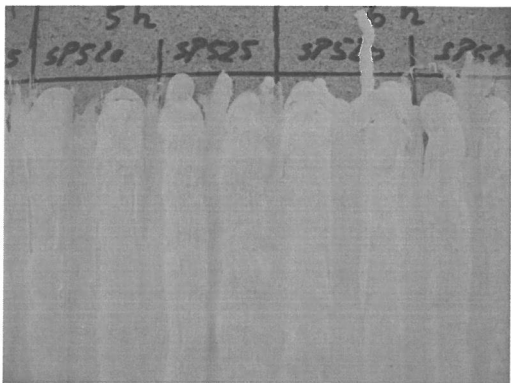
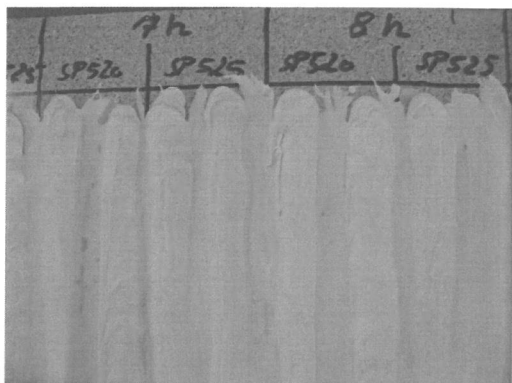
3. With coating on one hour cured sealant no incompatibility was evaluated.  
With coating on two hour cured sealant no incompatibility was evaluated.  
With coating on three hour cured sealant no incompatibility was evaluated.  
With coating on four cured sealant incompatibility (breaks, separation in coating surface) was evaluated.  
With coating on five cured sealant incompatibility (breaks, separation in coating surface) was evaluated.  
With coating on six cured sealant incompatibility (breaks, separation in coating surface) was evaluated.  
With coating on seven cured sealant incompatibility (breaks, separation in coating surface) was evaluated.  
With coating on eight cured sealant was incompatibility (breaks, separation in coating surface) evaluated.  
No staining was evaluated at all these samples.  
picture 003 till 006
